HO-423

Brick House Farm
4649 Sheppards Lane
Private

Maryland Inventory of Historic Properties Form

historic Brick House Farm

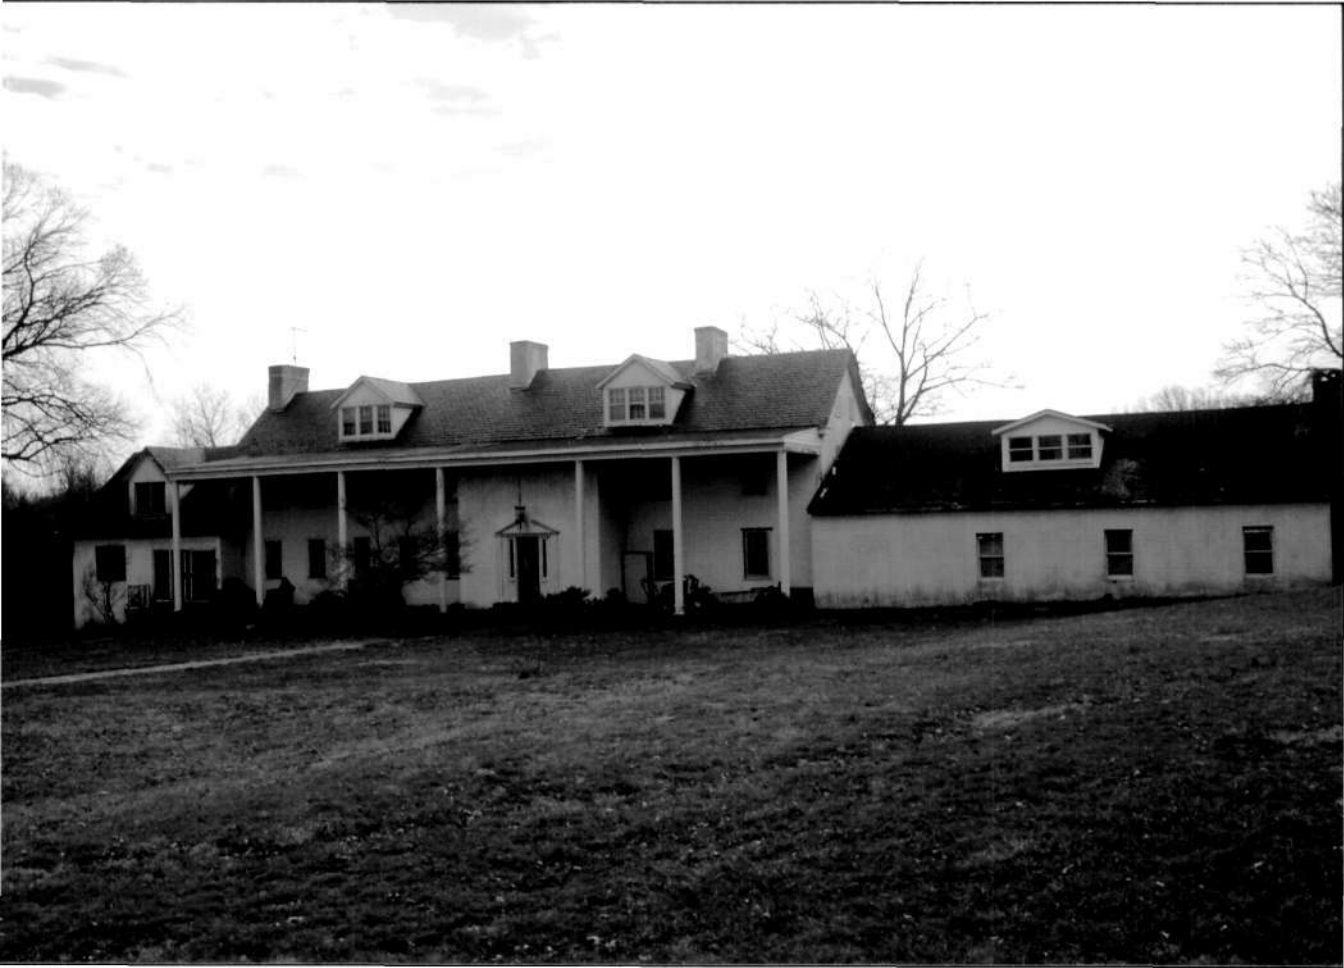
1 of 8

House, north elevation

On the north elevation the five east bays on both the first and second stories have a six-over-six sash with wood sills and head-cut trim. The sash date to the twentieth century. The two center bays project forward about 6 feet and have a twentieth-century six-panel wood door with stained glass sidelights, a

broken pediment with urn, and aluminum half columns. There is no opening on the second story. The two west bays on both the first and second stories have a six-over-six sash with wood sills and head-cut trim. There is a two-story porch across all nine bays, with brick veneer on the deck, seven aluminum columns, a stuccoed soffit, and applied dentil strips; all of this fabric dates to the twentieth century. The roof has two gabled dormers that are stuccoed and have triple six-over-six sash.

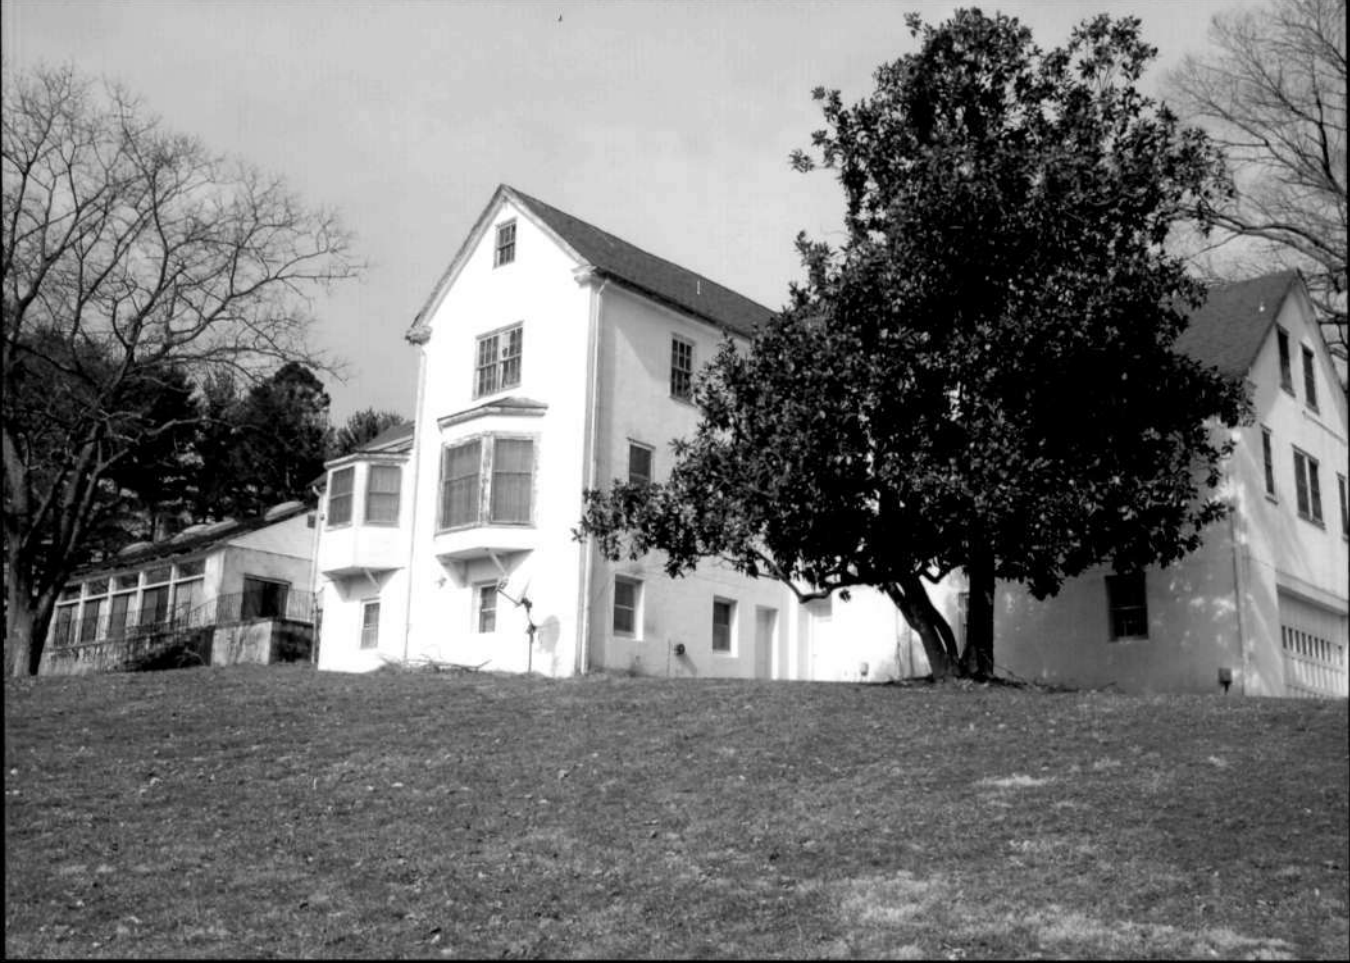
2 of 8

House, south+east elevations

The south elevation of the main block, east of the ell, is only one bay and has a door in the basement with six lights over two small panels over two tall panels. The first and second stories each have a six-over-six sash.

The east elevation of the ell, from south to north, has two six-over-six sash and a six-panel wood door in the basement. The first story has two six-over-six sash and a four-over-four sash. The second story has a six-over-six sash between the south and center bays and a four-over-four sash in the north bay.

The south elevation of the ell has a six-over-six sash in the basement. The first story has a three-sided bay window with an eight-over-twelve sash between six-over-nine sash. The second story has a pair of six-over-six sash and the gable end has a single six-over-six sash. The cornice has returns.

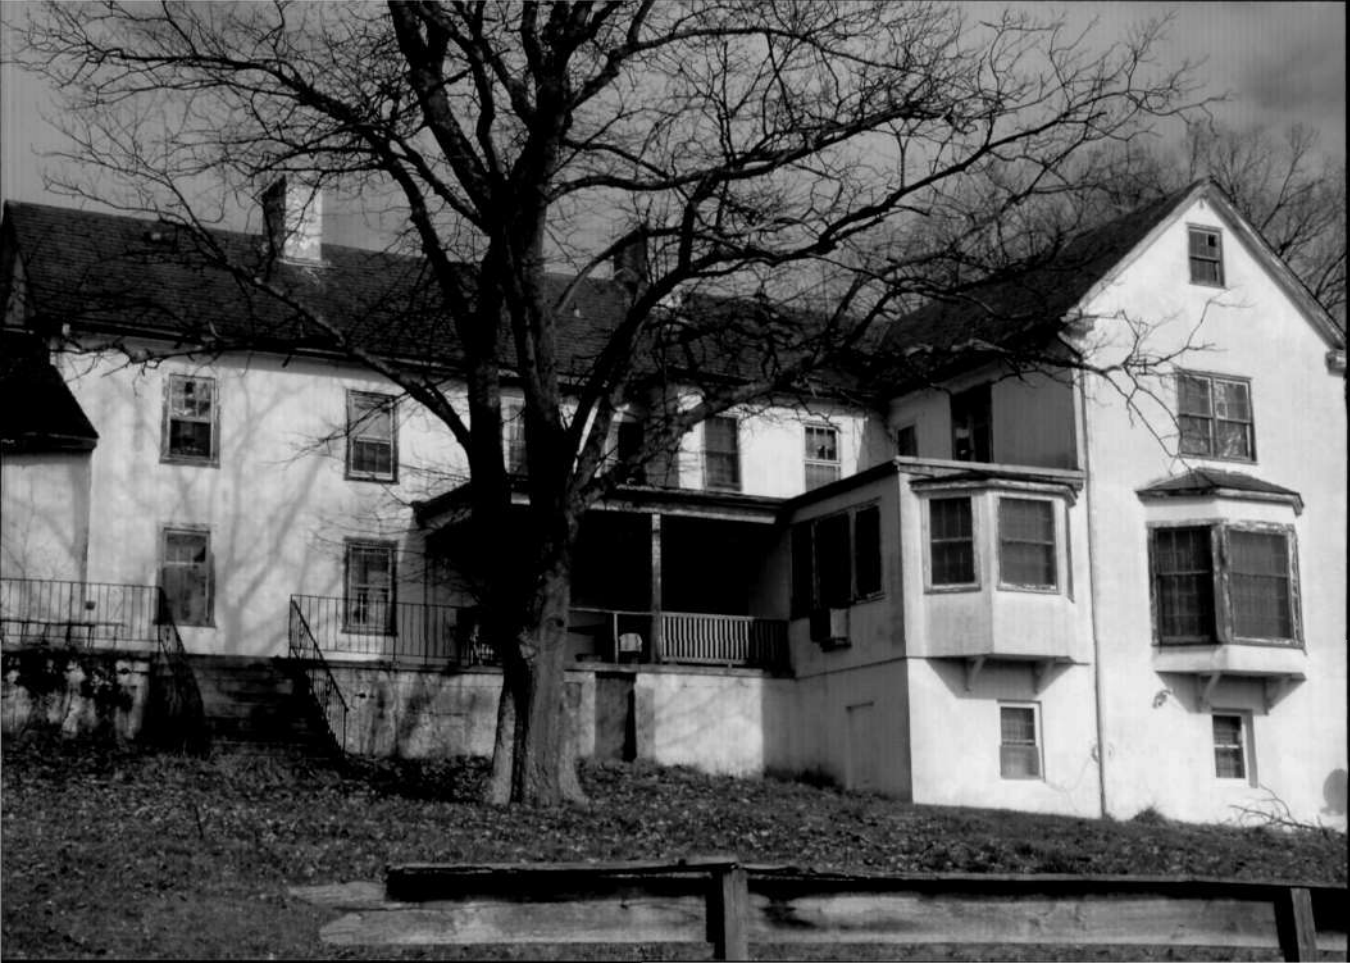
3 of 8

House, west & south elevations

The west elevation of the ell has the enclosed porch on the first story with an eight-over-eight sash to the north and a triple window to the south that has an eight-over-eight sash between six-over-six sash. The second story has no opening in the bumpout, with a six-over-six sash in the center bay and a pair of ten-light French doors in the south bay.

The south elevation of the main block, west of the ell, on the first story, has, from west to east, two six-over-six sash, a six-panel wood door, a six-over-six sash, and the enclosed porch over the two east bays prior to the ell. The south end of this enclosed porch has a three-sided bay window with an eight-over-eight sash between six-over-six sash. The porch is built on concrete piers with CMUs in between, and has square posts and balusters. The second story has two six-over-six sash, a pair of ten-light French doors, and a bump-out with two six-over-six sash. There is an open porch in front of the two western bays.

The west gable end, above the modern addition, has two small windows that are boarded up, and the cornice has returns.

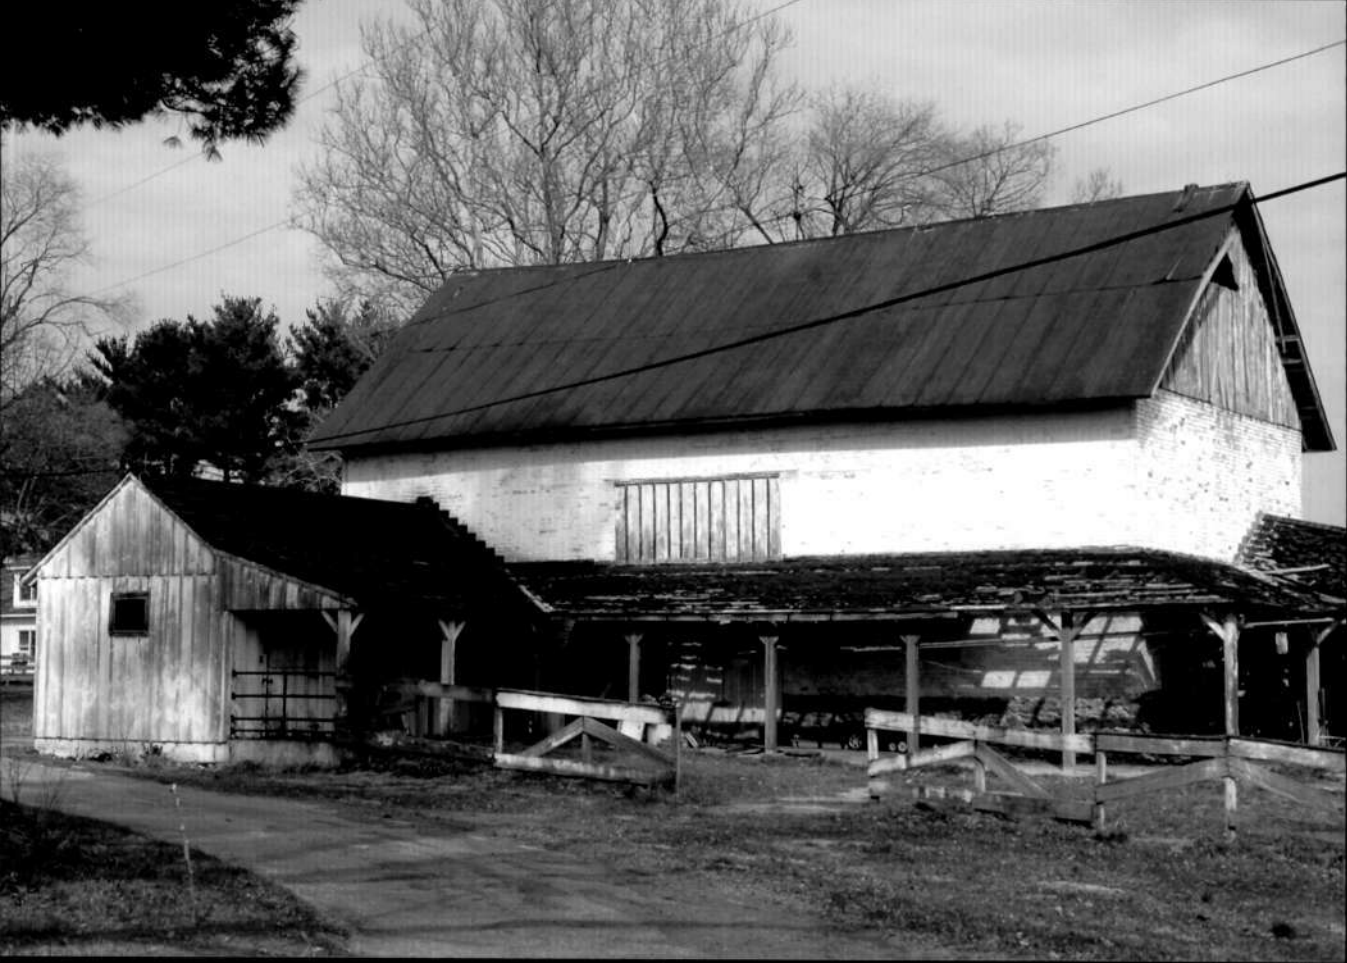
4 of 8

Brick barn, south + east elevations

The south elevation has a modern shed attached to the west bay, with a shed-roofed porch across the center and east bays. The center bay has a large opening with a wood lintel, and the opening is enclosed with board-and-batten siding and contains a pair of Dutch doors and a six-over-six sash. The east bay has a six-over-six sash with head-cut trim, a wood sill, and no jack arch.

The east elevation has a six-light sash to the north and a modern shed with stables attached here. The shed is collapsing and has a CMU foundation, board-and-batten siding, and a gable roof with asphalt shingles and an east-west ridge. It is built of dimensional lumber and steps down the hill to the east. The gable end has a triangular opening.

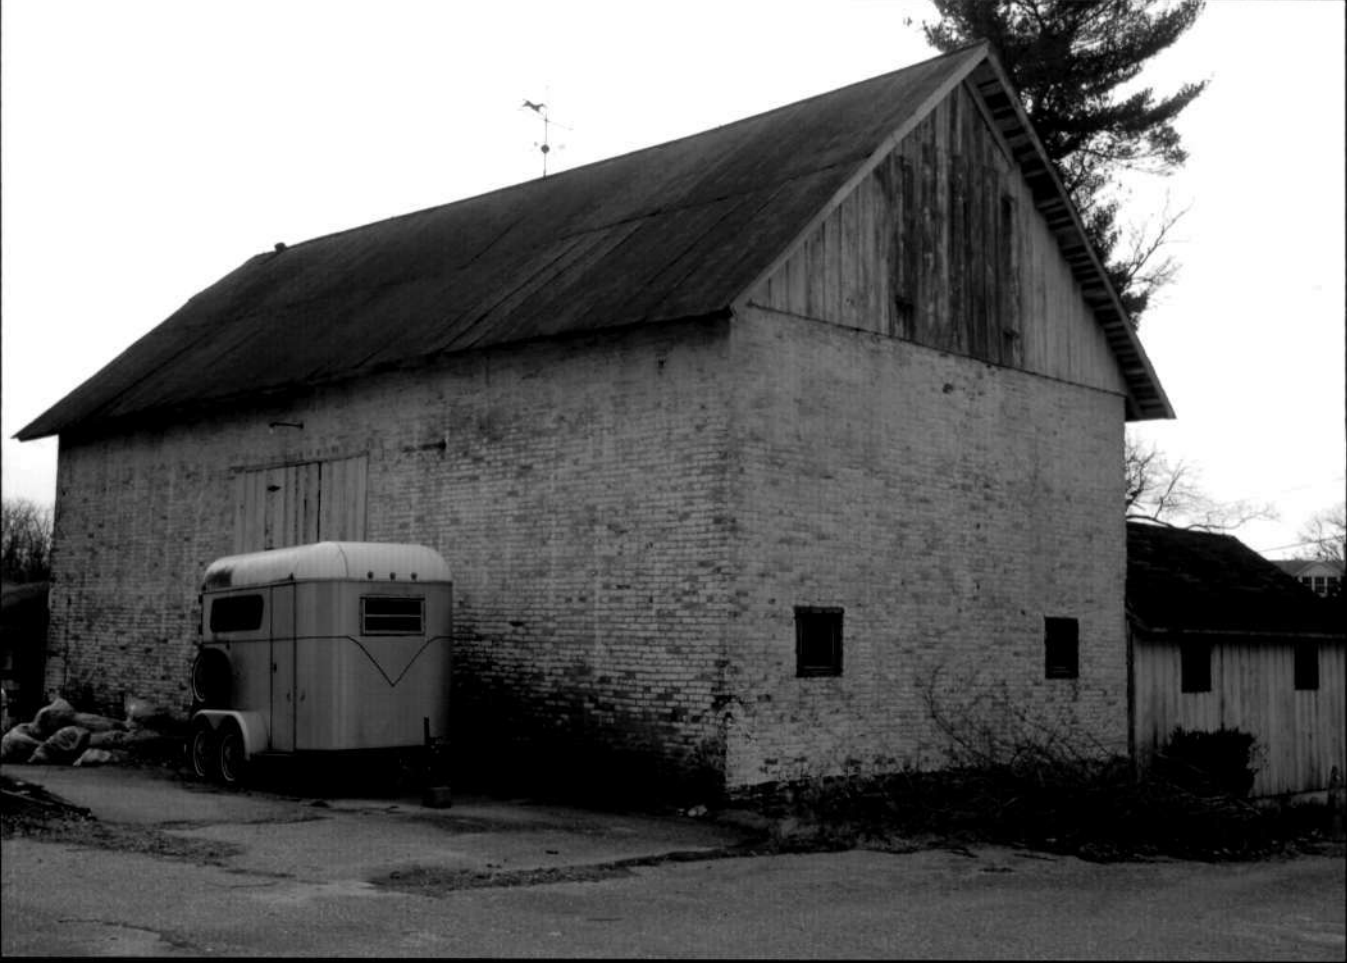
5 of 8

Brick barn, north+west elevations

The north elevation center bay is in-filled with board-and-batten siding, and has a short door above a Dutch door, all hung on butterfly hinges. There is a one-light sash to the west of the door.

The west elevation has two small openings cut through, with four vertical metal bars in each and glass added. The gable end has double doors on butterfly hinges.

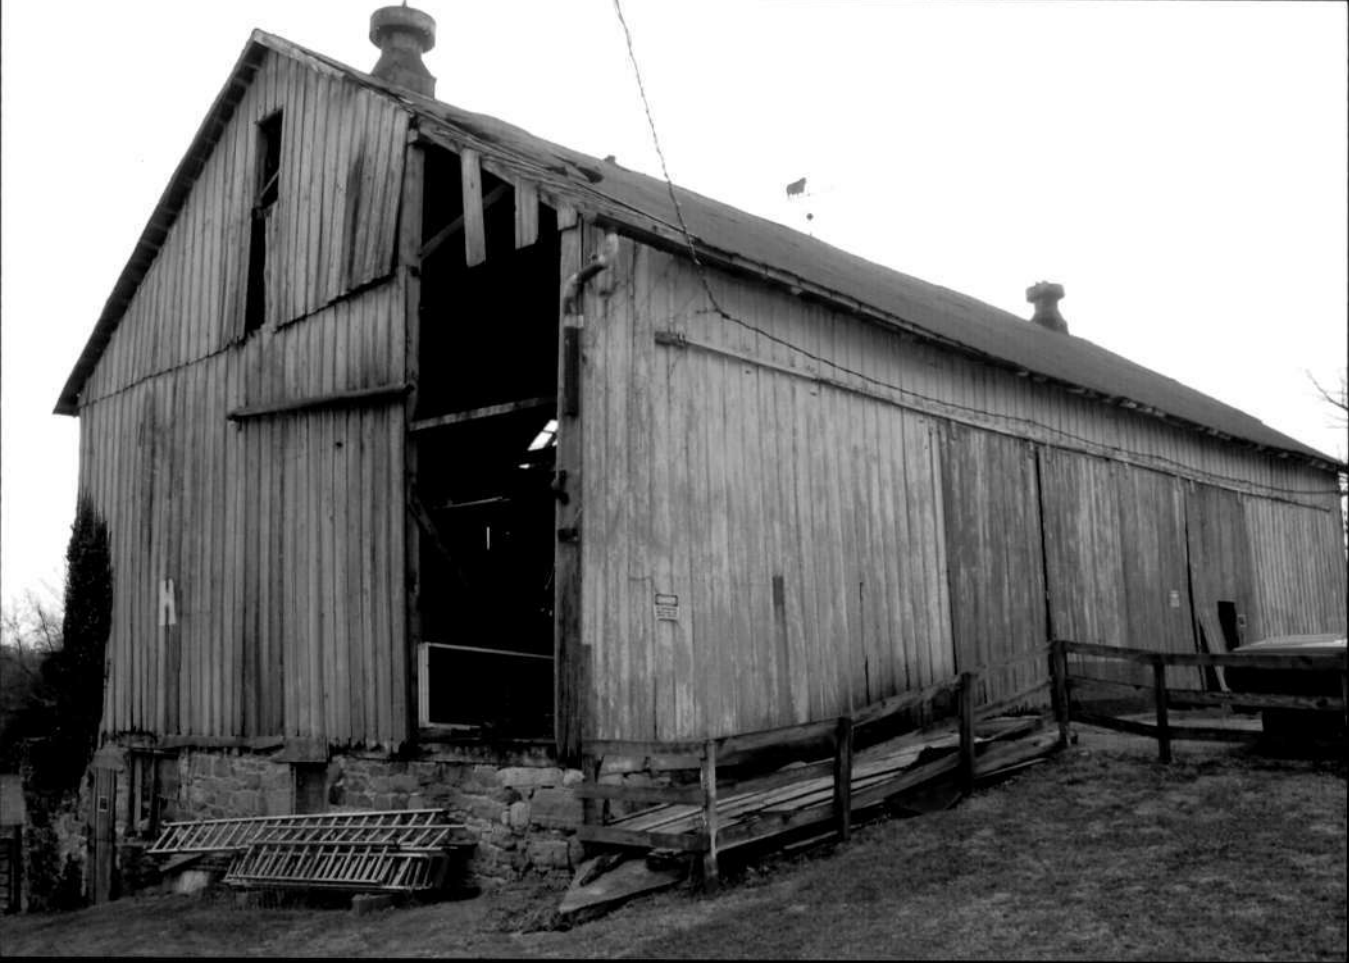
6 of 8

Bank barn, north+west elevations

The west elevation has the lower story covered by the ramp. The upper story has two pair of wagon doors hung on rollers, in the two center bays. The south elevation has a nine-light sash in the west bay and a six-over-six sash in the east bay of the lower story. The north and south foundation walls extend about 4 feet beyond the east wall of the upper story.

The north elevation has a pair of six-over-six sash in the east bay of the lower story and a nine-light wood sash in the west bay. The upper story has a window opening in the center.

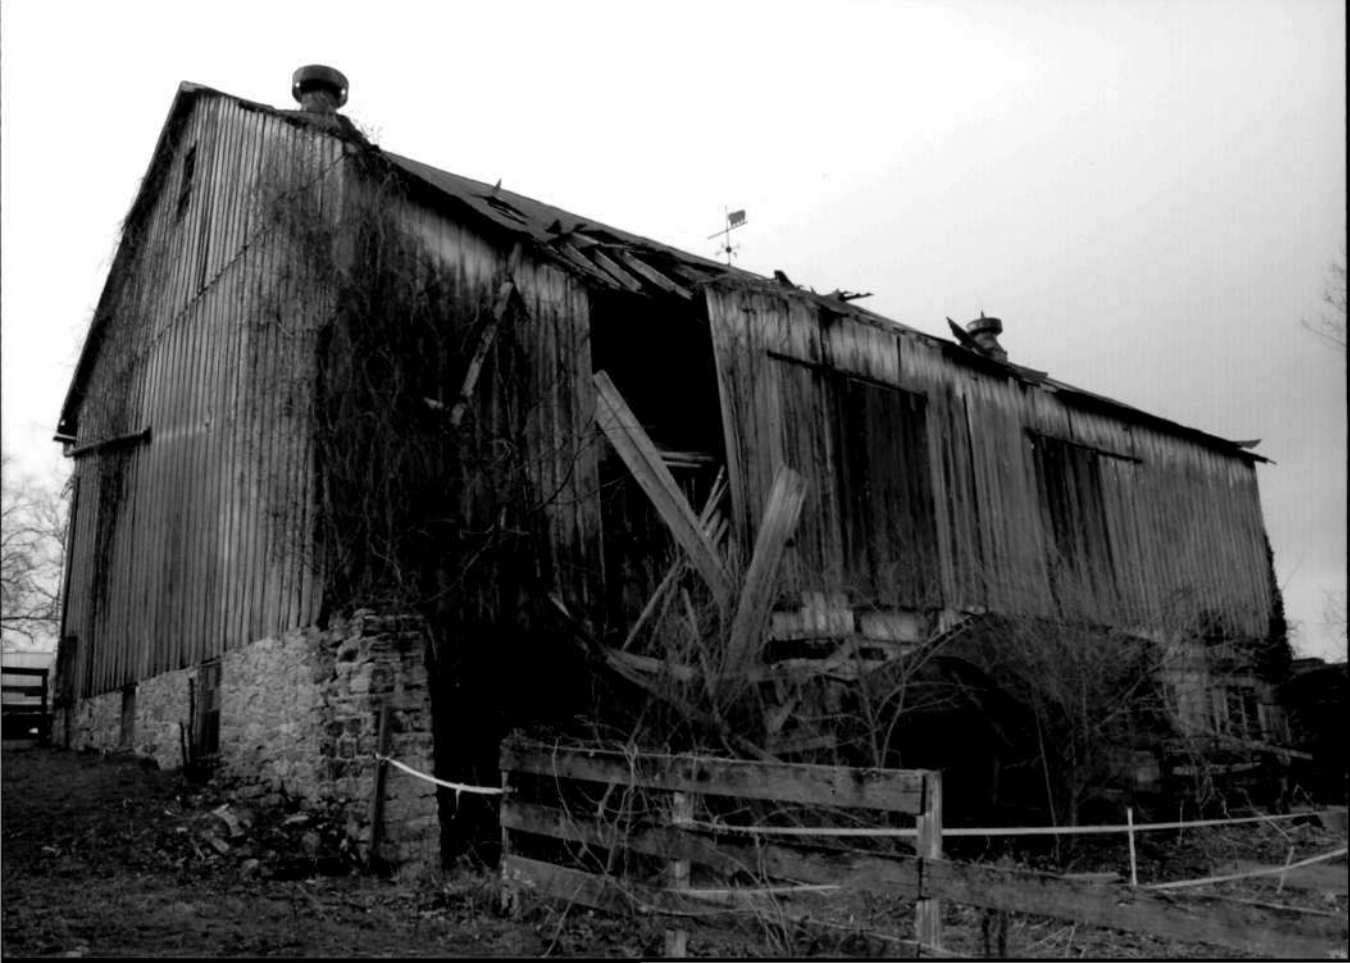
7 of 8

Bank barn, south+east elevations

On the east elevation the lower story has collapsed on the south end. The north end is frame with a lot of window openings. There is a collapsed shed roof across the whole lower story east wall. The upper story two center bays each have a vertical board door on rollers. There are numerous holes in the roof here.

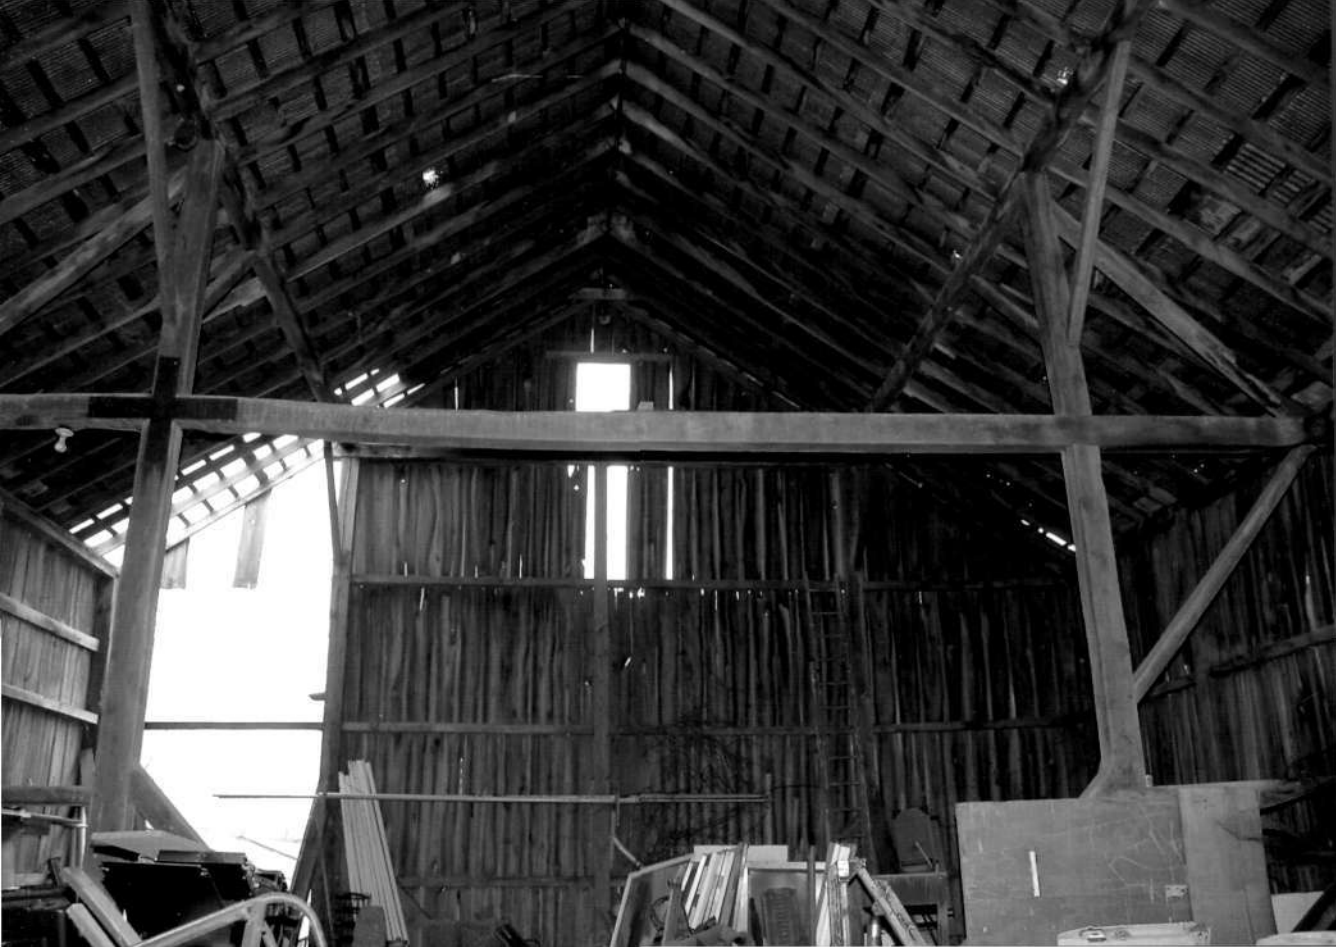
8 of 8

Bank barn, upper story interior,

VW north

The interior of the lower story has two circular-sawn summer beams that run north-south, with posts below the summers, and circular-sawn joist sit on top. The upper story has a circular-sawn heavy timber frame that is mortised and tenoned and pegged. The rafters are approximately 2 by 6s that are mitered and butted at the ridge, and there is a hay track.
